SPILLWAY TESTS AT GLEN CANYON DAM

July 1985

Bureau of Reclamation

Hydraulics Branch
Division of Research and Laboratory Services
Engineering and Research Center
Denver, Colorado
July 1985

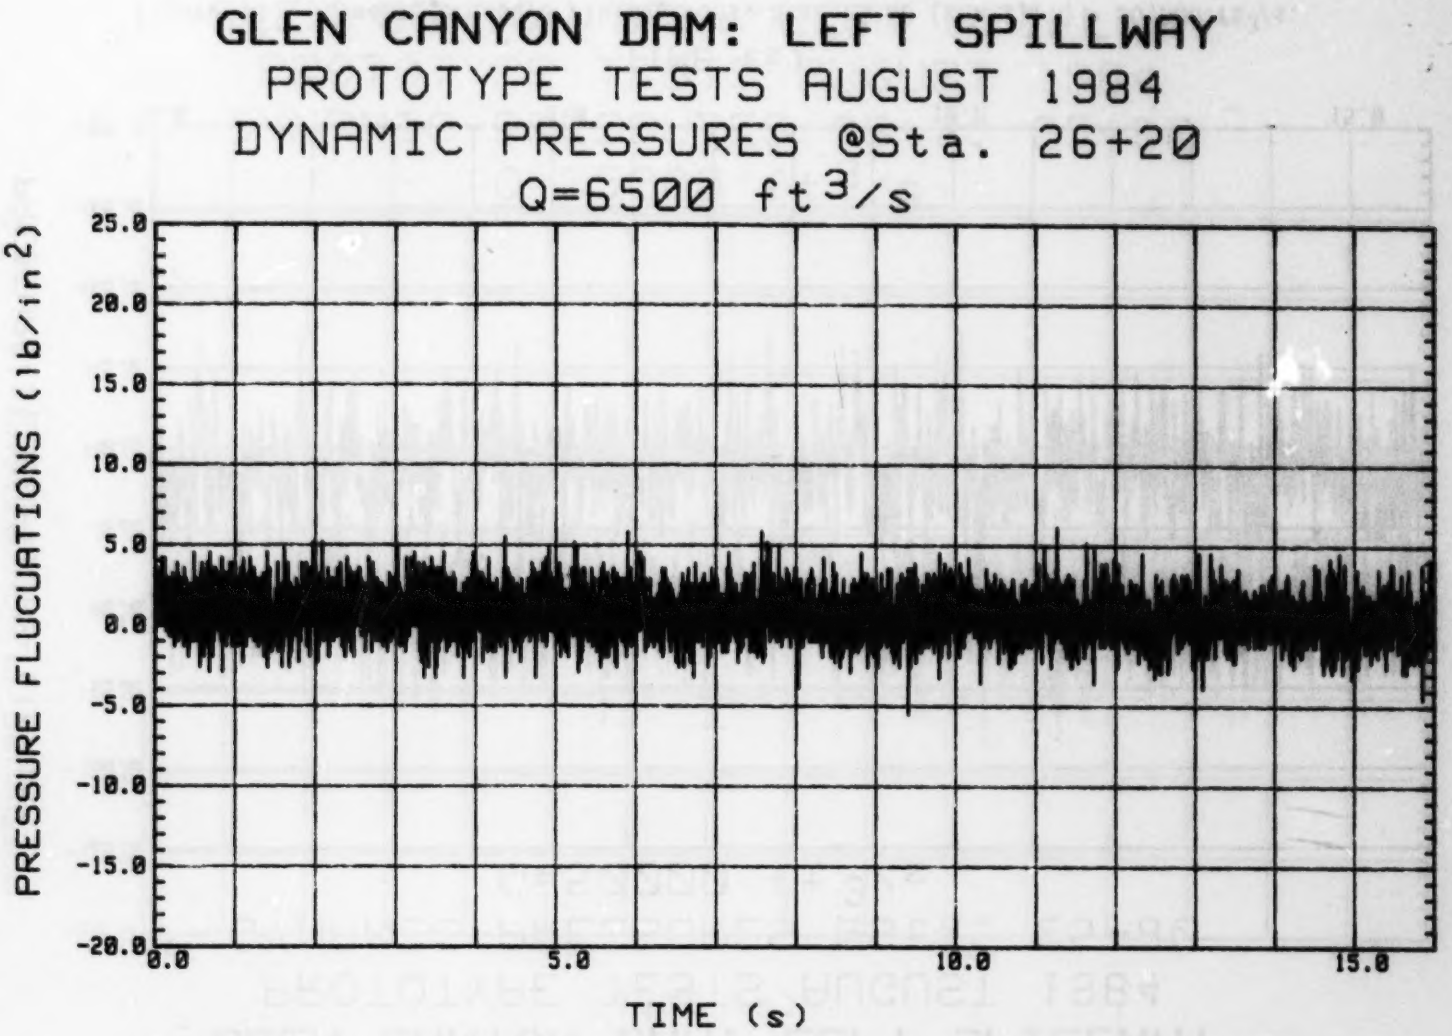
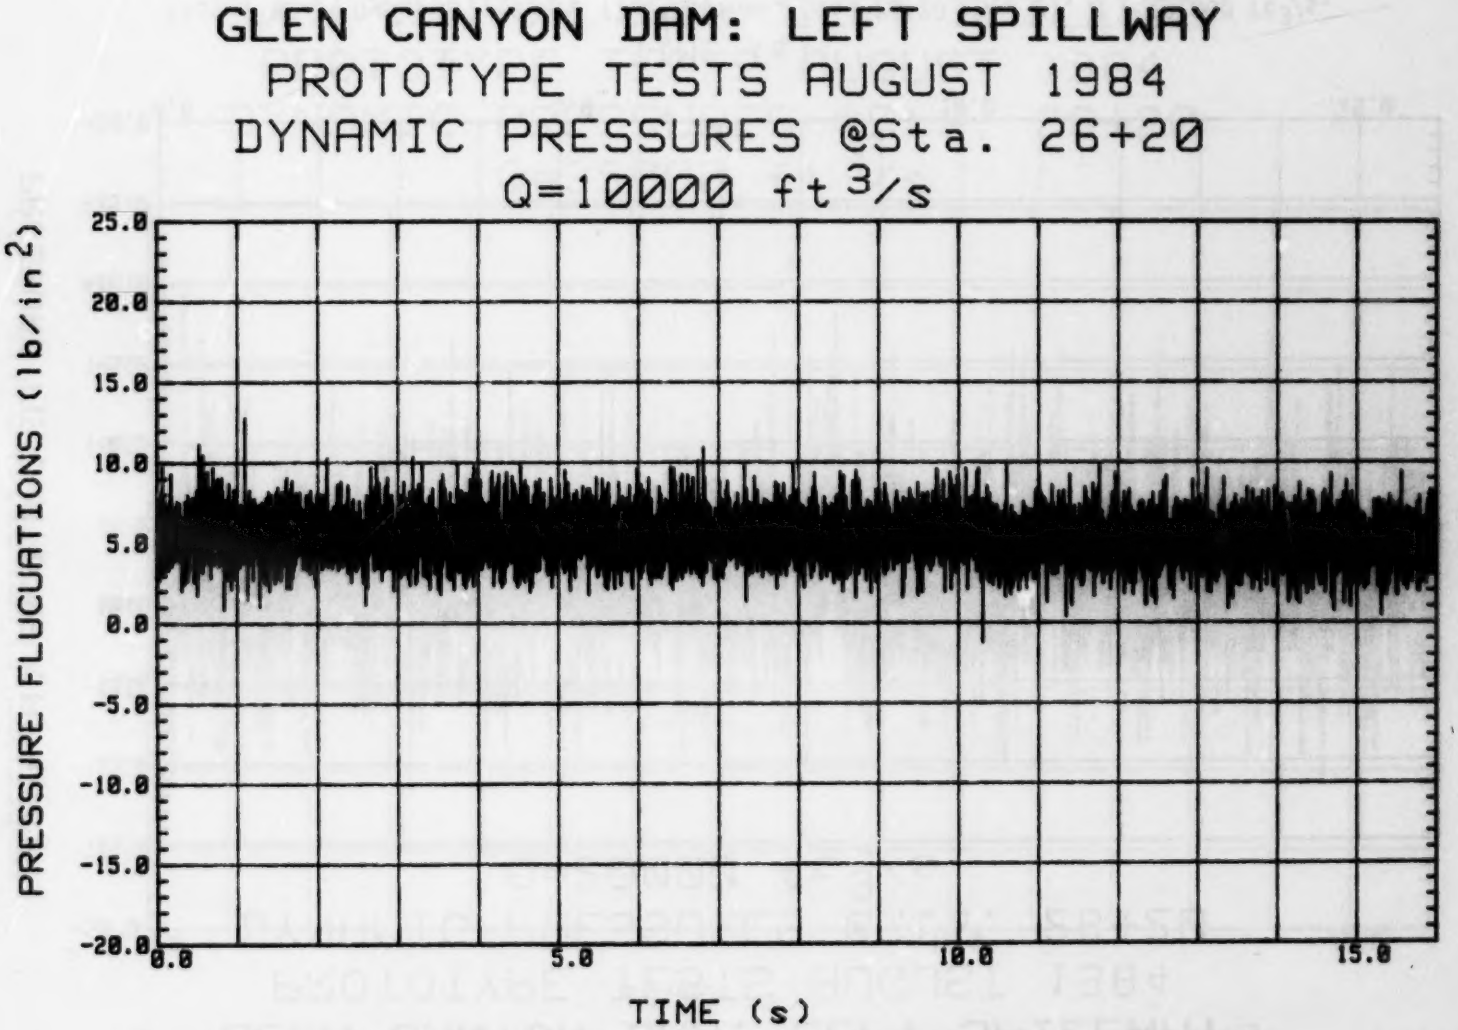
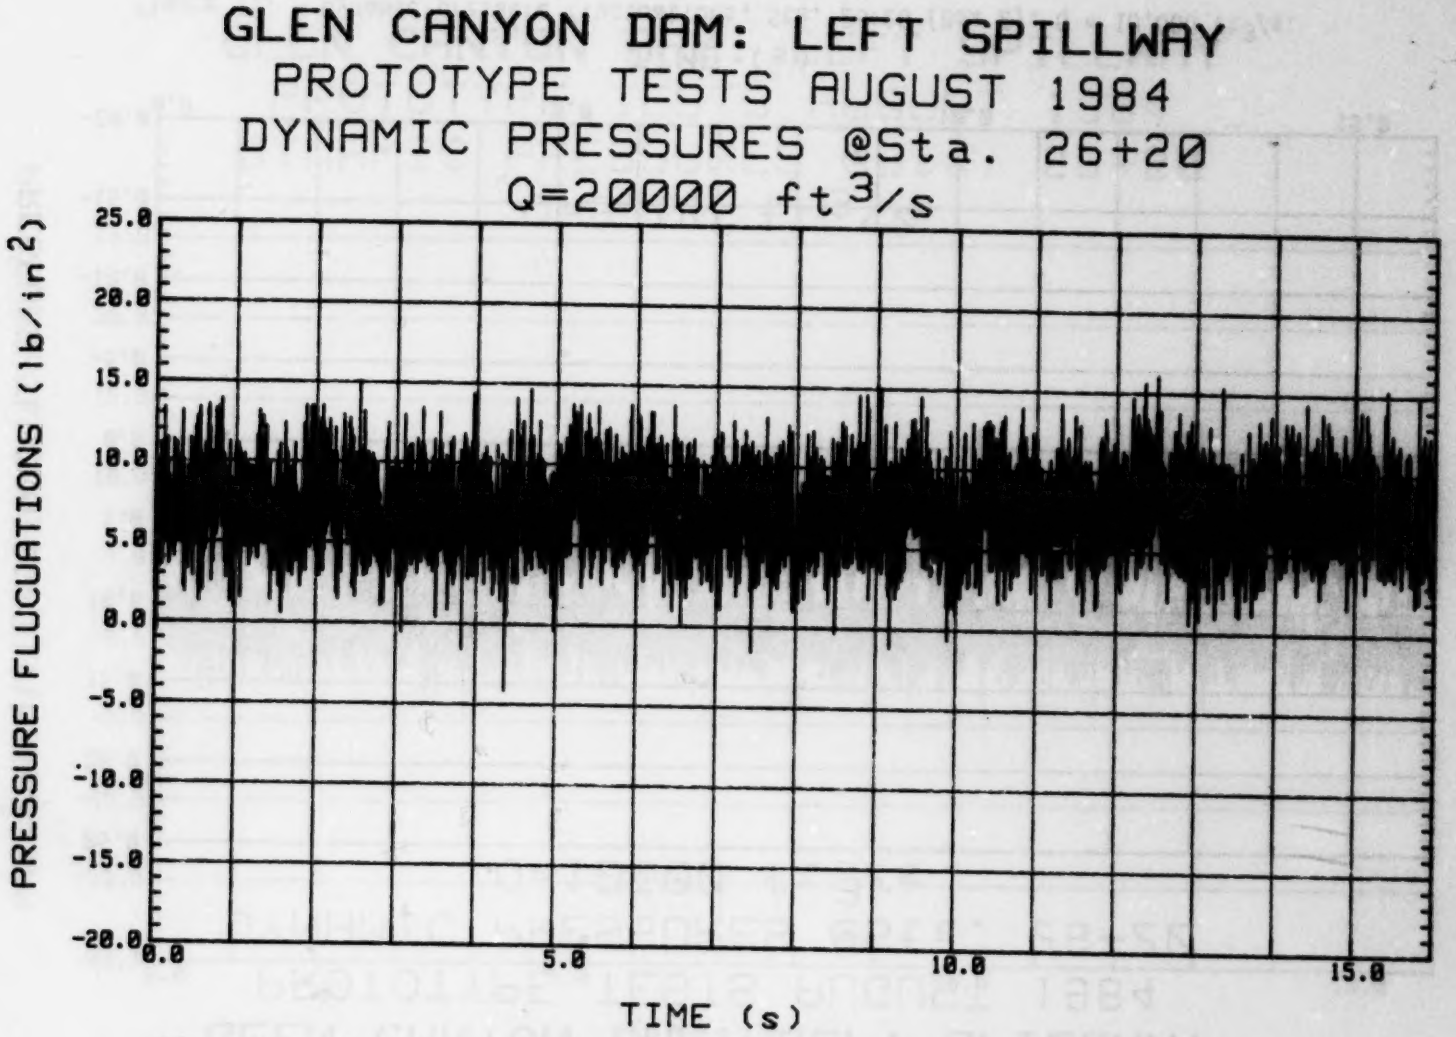
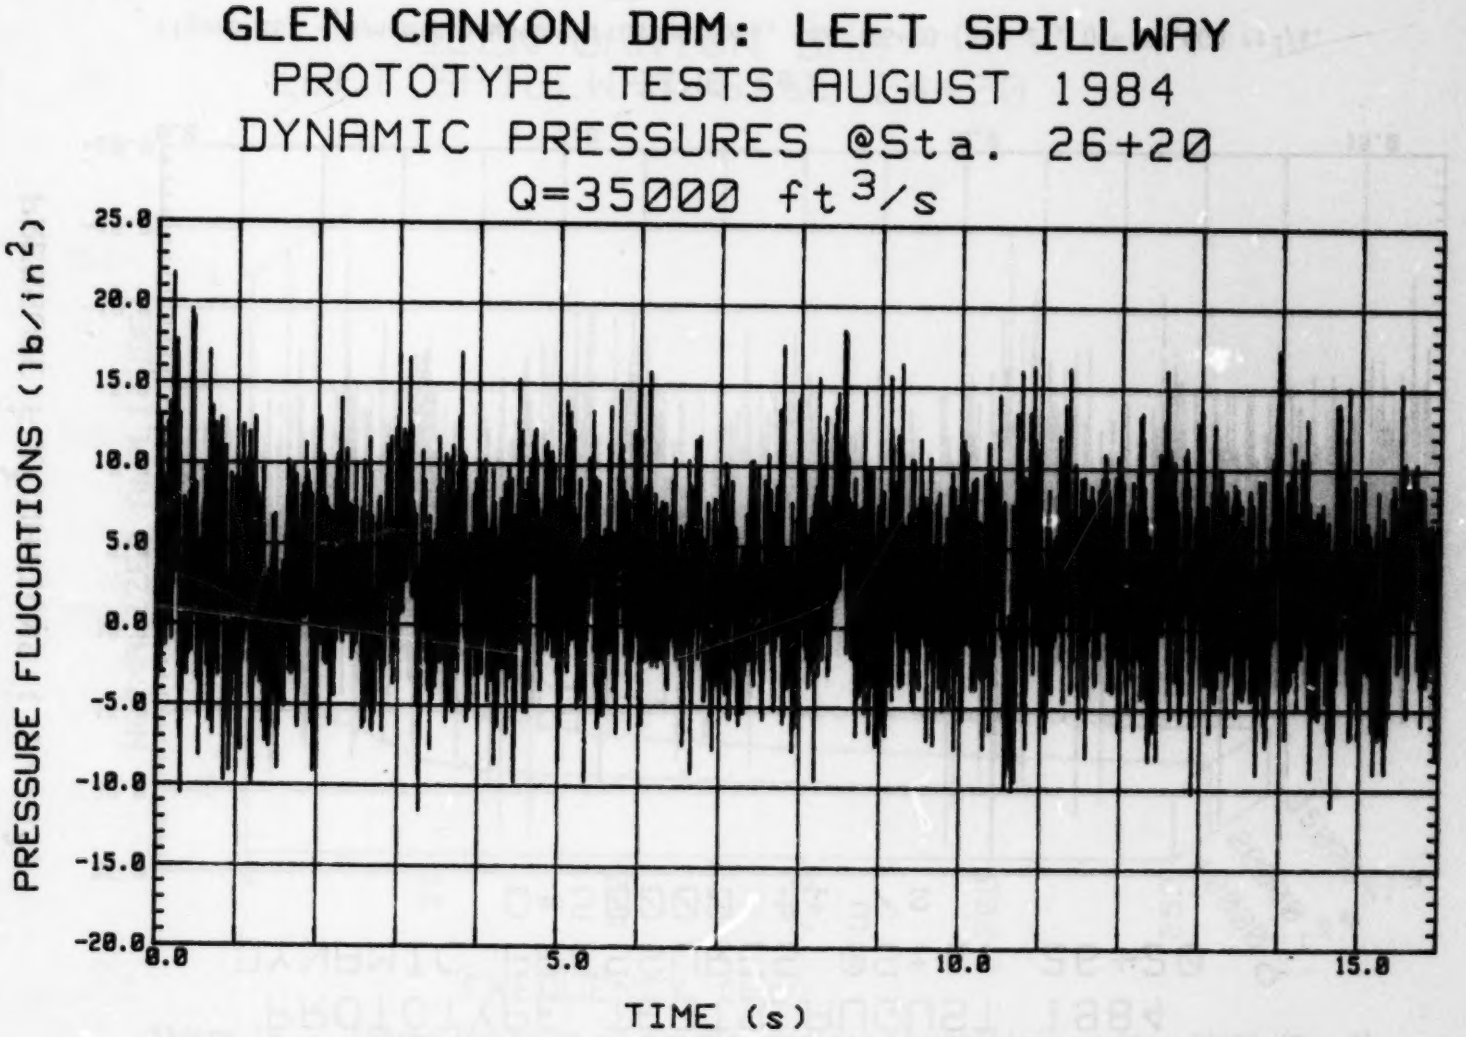
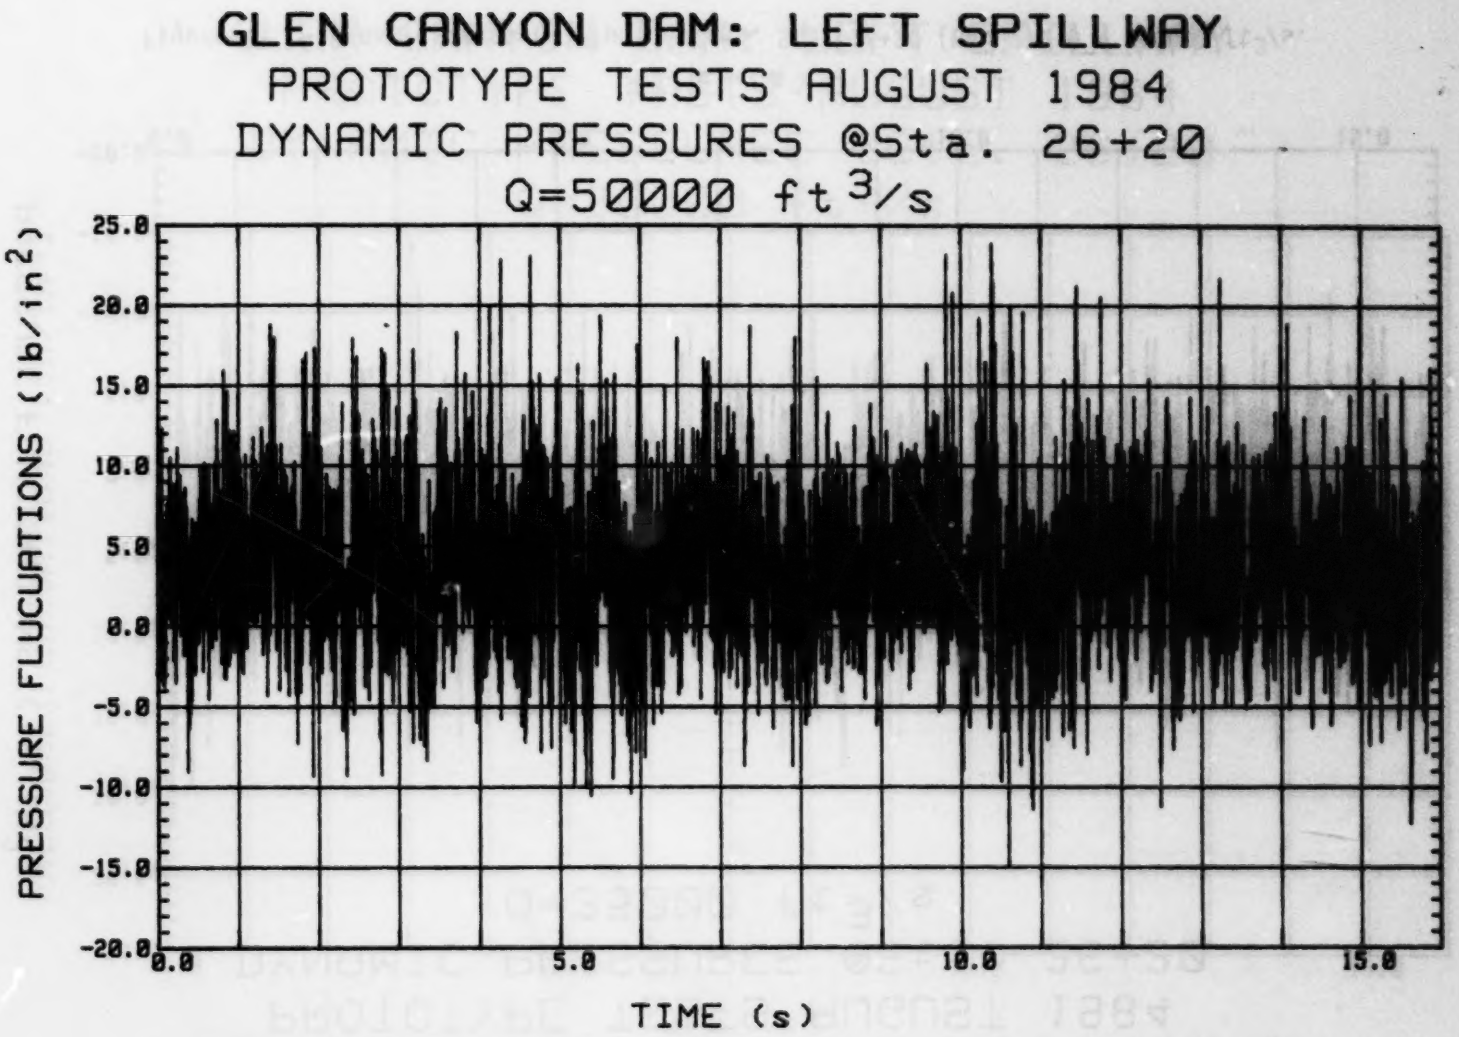
Figure 14. - Dynamic pressure fluctuations, Sta. 26+20 (Box 2), Q = 6,500 ft^3/s.

Figure 15. - Dynamic pressure fluctuations, Sta. 26+20 (Box 2), Q = 10,000 ft^3/s.

Figure 16. - Dynamic pressure fluctuations, Sta. 26+20 (Box 2), Q = 20,000 ft^3/s.

Figure 17. - Dynamic pressure fluctuations, Sta. 26+20 (Box 2), Q = 35,000 ft^3/s.

Figure 18. - Dynamic pressure fluctuations, Sta. 26+20 (Box 2), Q = 50,000 ft^3/s.

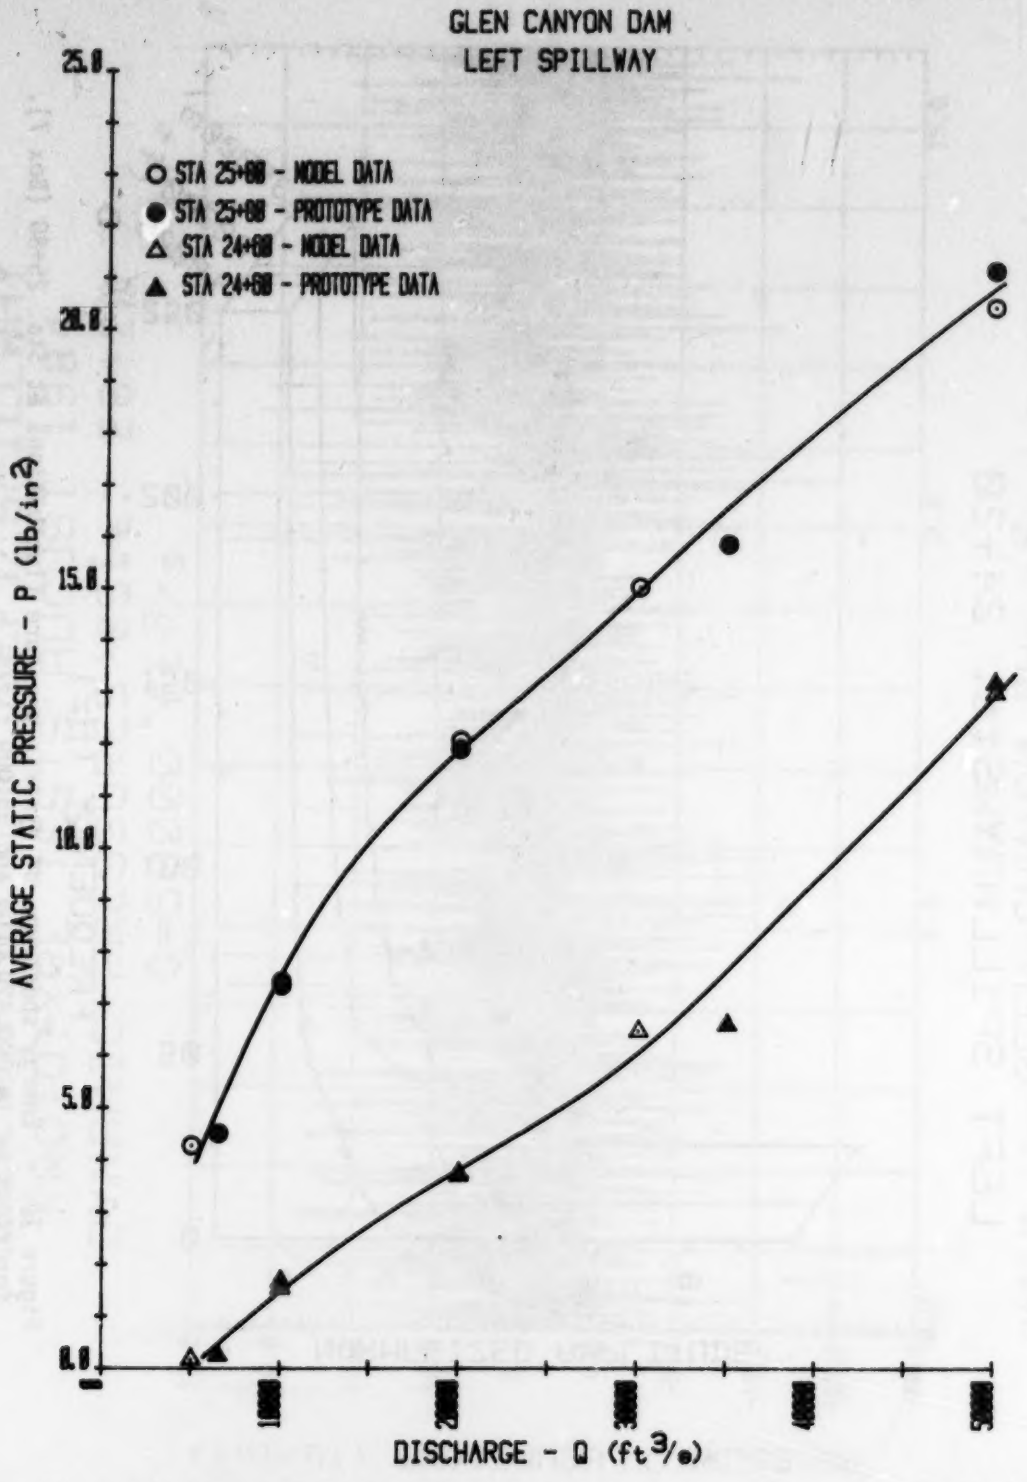
Figure 20. - Model-prototype comparison of static pressures at sta. 24+60 (Box 6), and Sta. 25+80 (Box 3).

A comparison of model and prototype static pressures from the available data is shown on figure 20. These compare well; however, dynamic pressure fluctuations present problems with scaling since, not only amplitudes, but frequencies are important. The mean pressure fluctuations for all flowrates were positive. This indicates that there are more positive pulses than negative, or that the amplitude of the positive spikes was much greater.

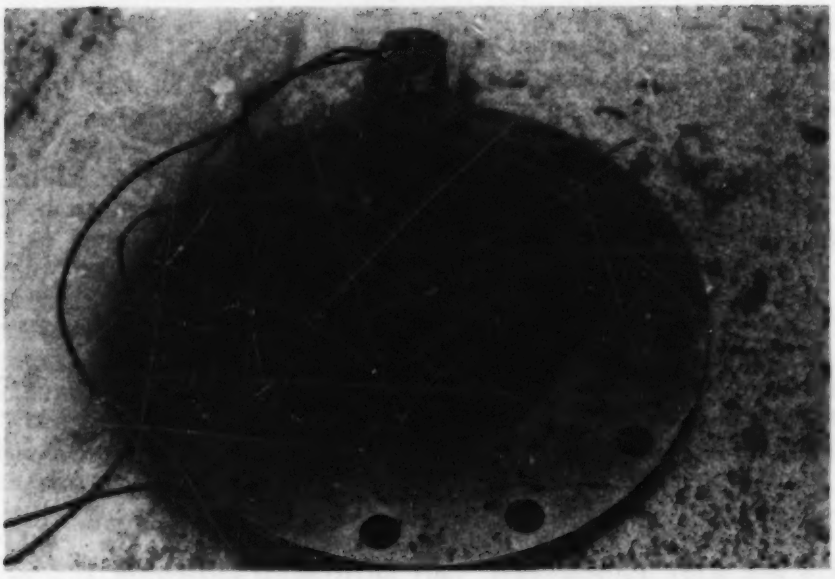
(a) Front face with tap.

(b) Rear face with transducer and wiring.

Figure 1. - Kulite absolute pressure cell, installed in boxes 1 and 6.

(a) Front face with static tap and dynamic flushmount.

(b) Rear face with transducer connections.

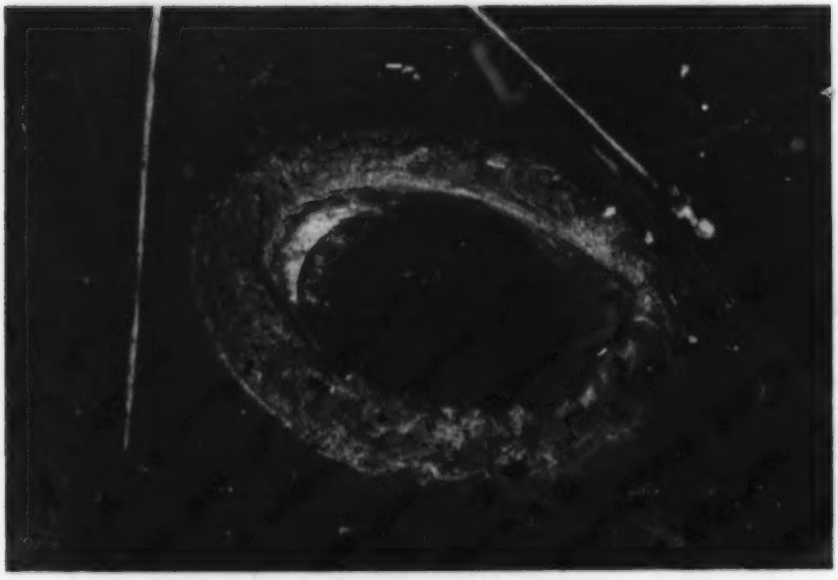
(a) Boxes 1-7 with water diversion structures in place.

(b) Typical installation.

Figure 6. - Boxes 1-7 in lower elbow and horizontal tunnel section of left spillway.
